OREGON DEPARTMENT OF ENVIRONMENTAL QUALITY - INVESTIGATION PHOTOLOG
FACILITY NAME: Hydo Extrusions – Coating Division 5325 NE Skyport Way Portland, OR 97218
EPA ID# ORD982656076
ACDP Permit 26-3241-ST-1
Stormwater Permit File 104692
BES Wastewater Permit 433.035

DATE: May 21, 2020

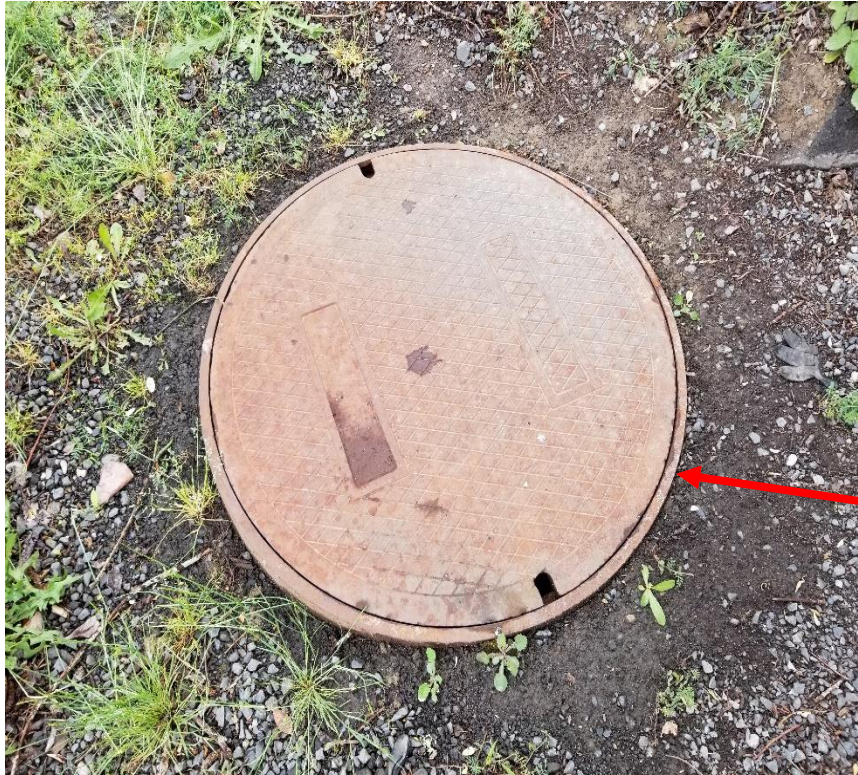
1:

Stormwater sedimentation chamber located on the NE corner of the property.

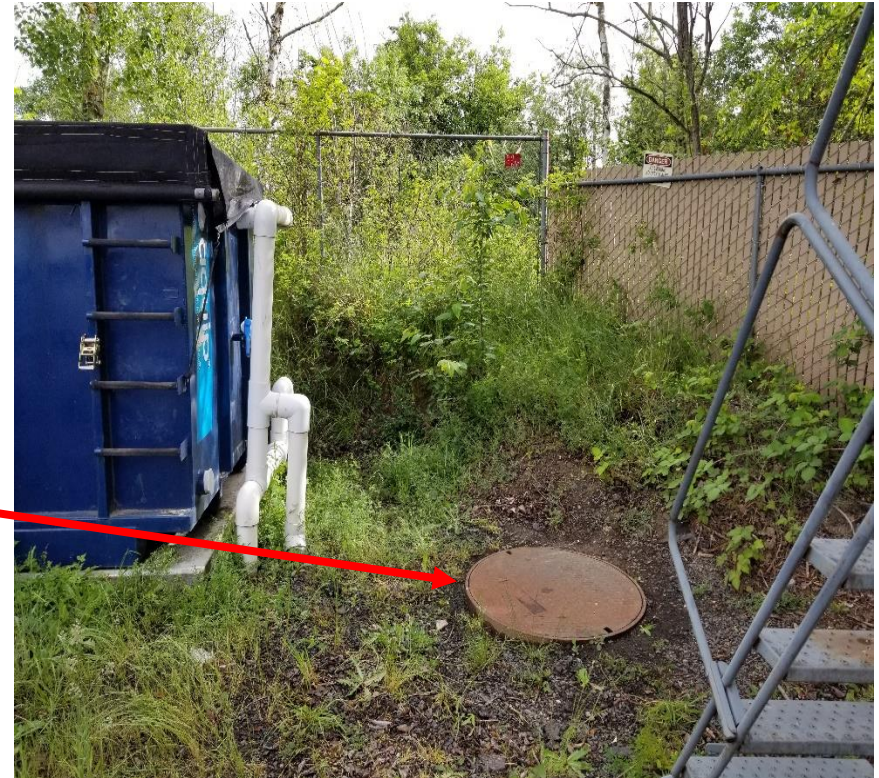
2:

Stormwater sedimentation chamber and stormwater filtration unit "Aquip" located on the NE corner of the property.

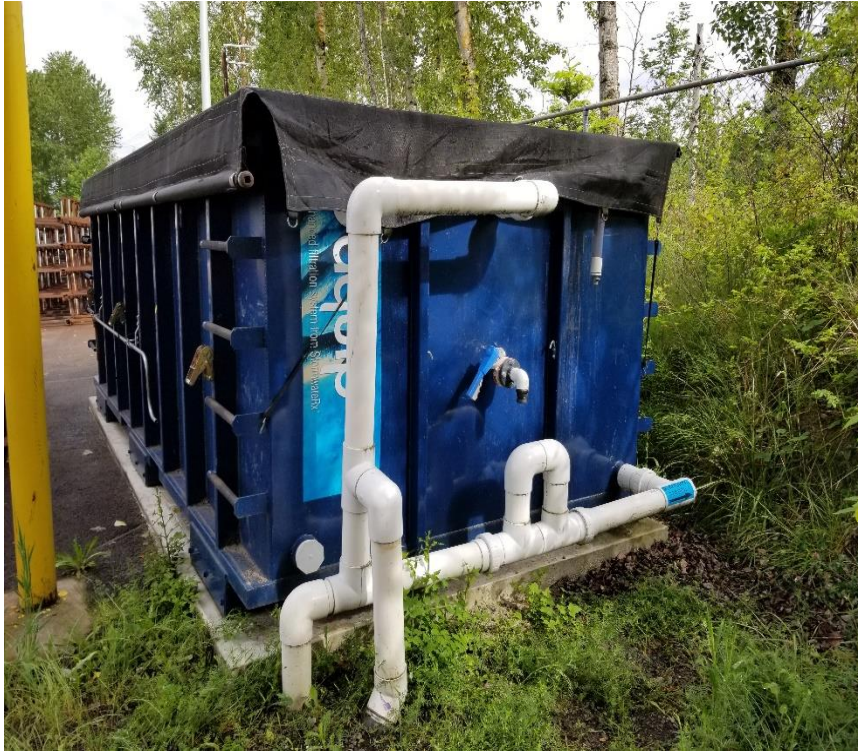
3:

Stormwater filtration unit “Aquip.” Eastside of Aquip showing discharge piping and sampling port.

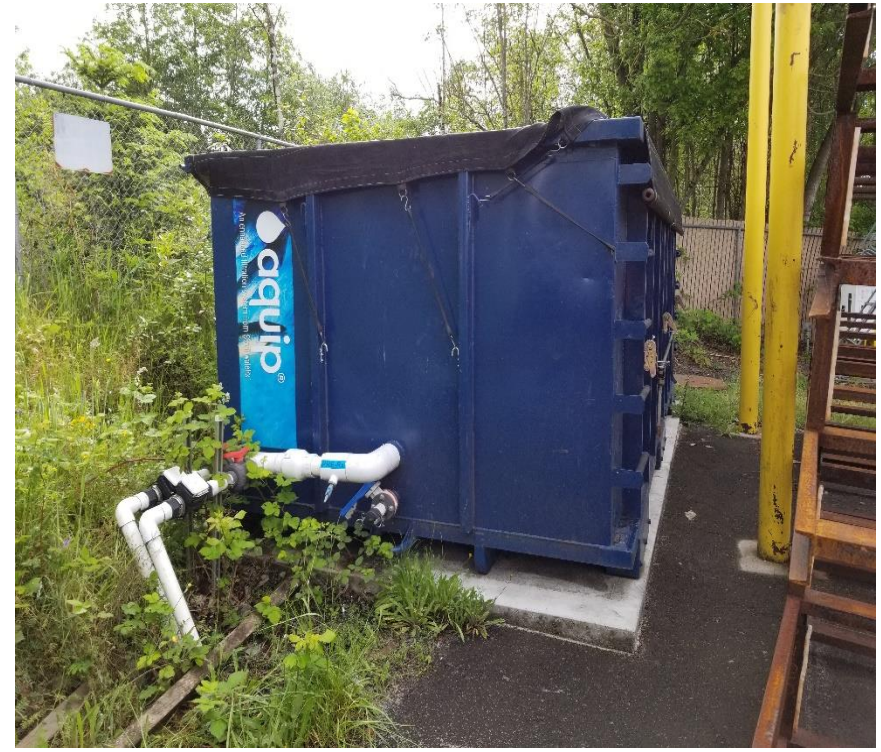
4:

Stormwater filtration unit “Aquip.” Westside of Aquip showing intake piping routed from stormwater sedimentation chamber directed into the pre-filter of the Aquip.

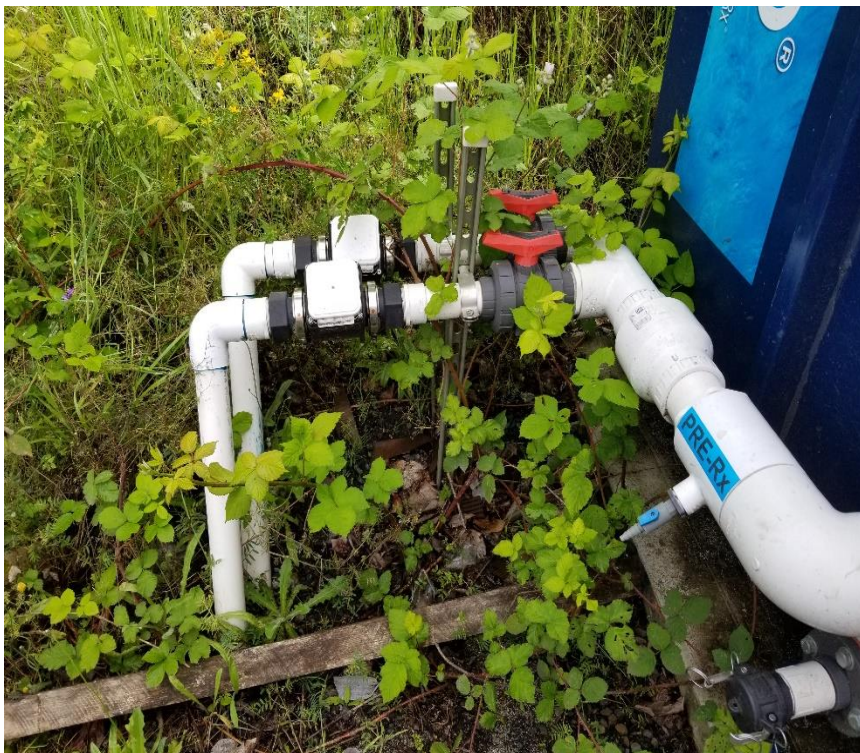
5:

Stormwater inlet piping equipped with flowmeter and isolation valves.

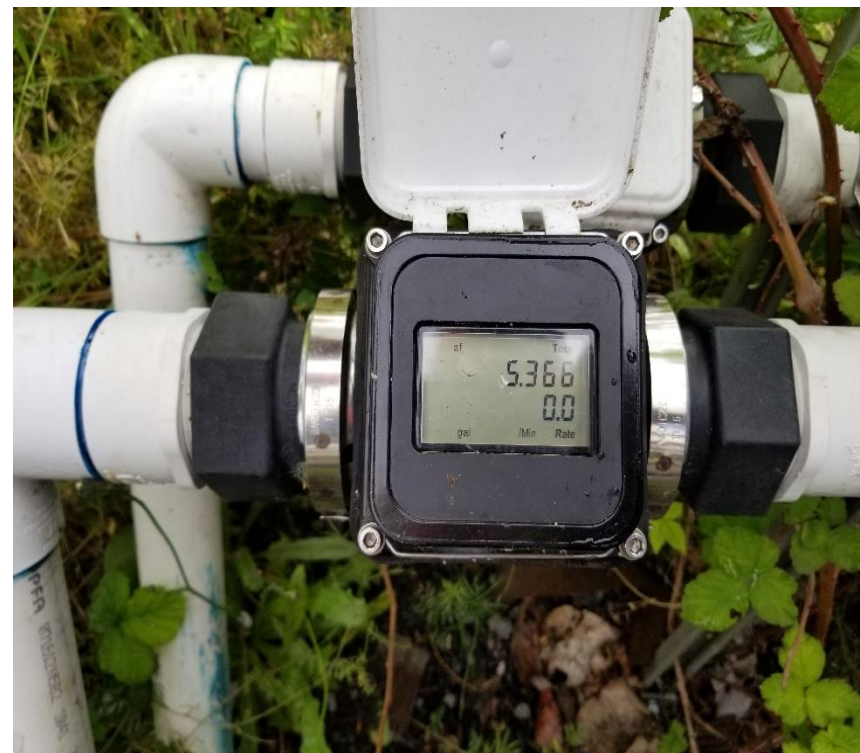
6:

Stormwater inlet flowmeter observed at a flowrate of 5.366 gallon per minute.

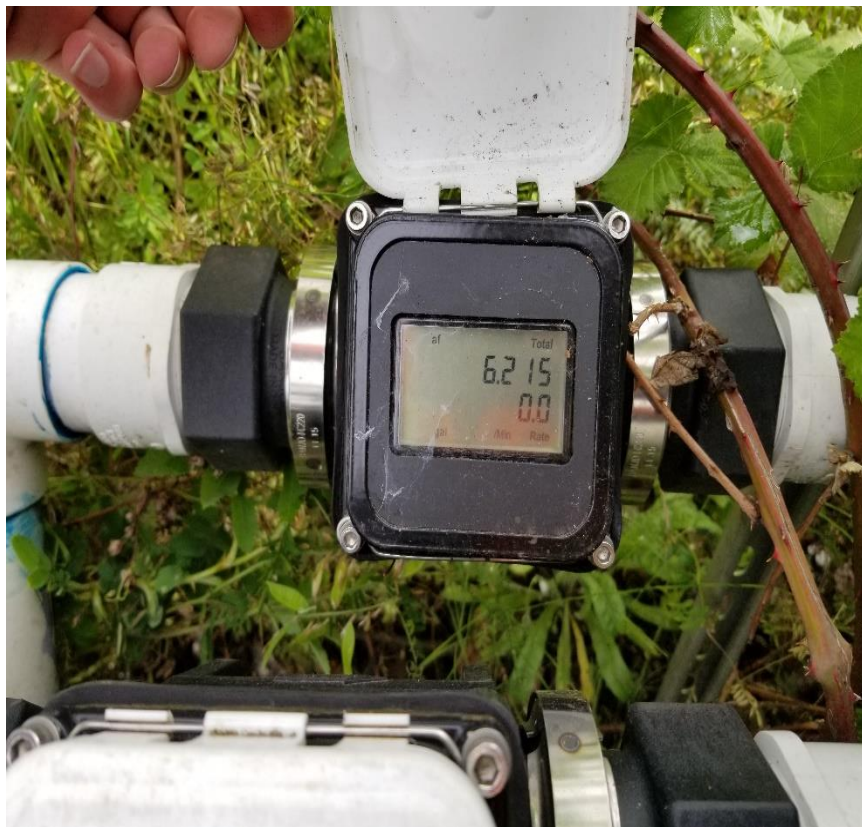
7:

Second stormwater inlet flowmeter observed at a flowrate of 6.2015 gallon per minute.

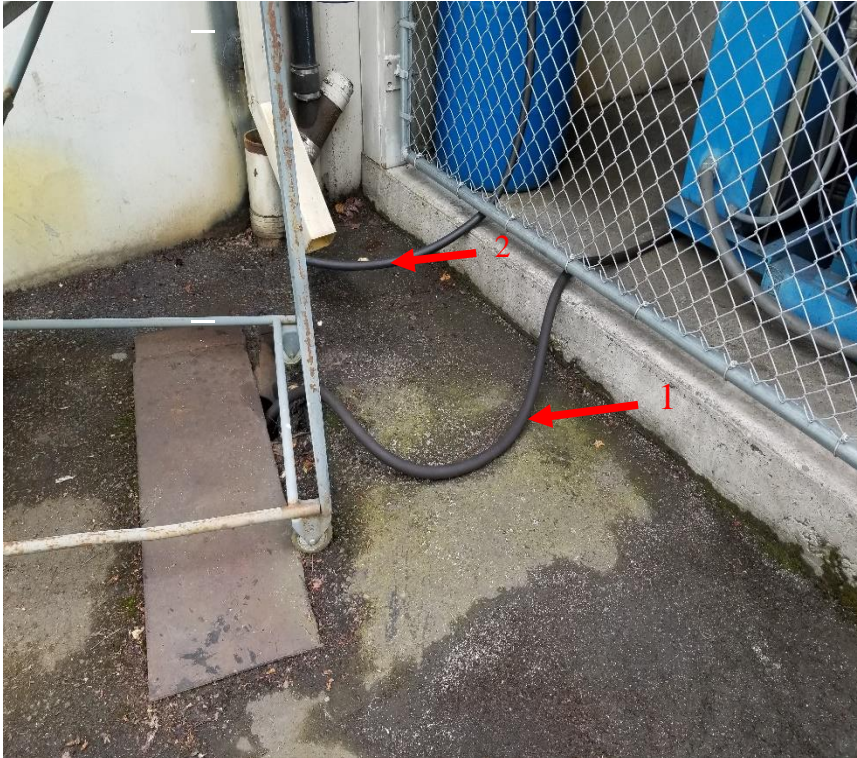
26:

- First (1) black hose connected to a blue polyethylene container labeled “oil/water separator” located in the eastside exterior air-compressor room routed to a broken stormwater pipe. This “oil/water separator” is connected to the condensate discharge for the air-compressor.
- Second (2) black hose connected to a blue polyethylene container labeled “oil/water separator” located in the eastside exterior air-compressor room directed to a broken stormwater pipe. This “oil/water separator” is connected to a vertical hardline affixed to the exterior of the facility and statted to be connected to the facility air-dryer unit.

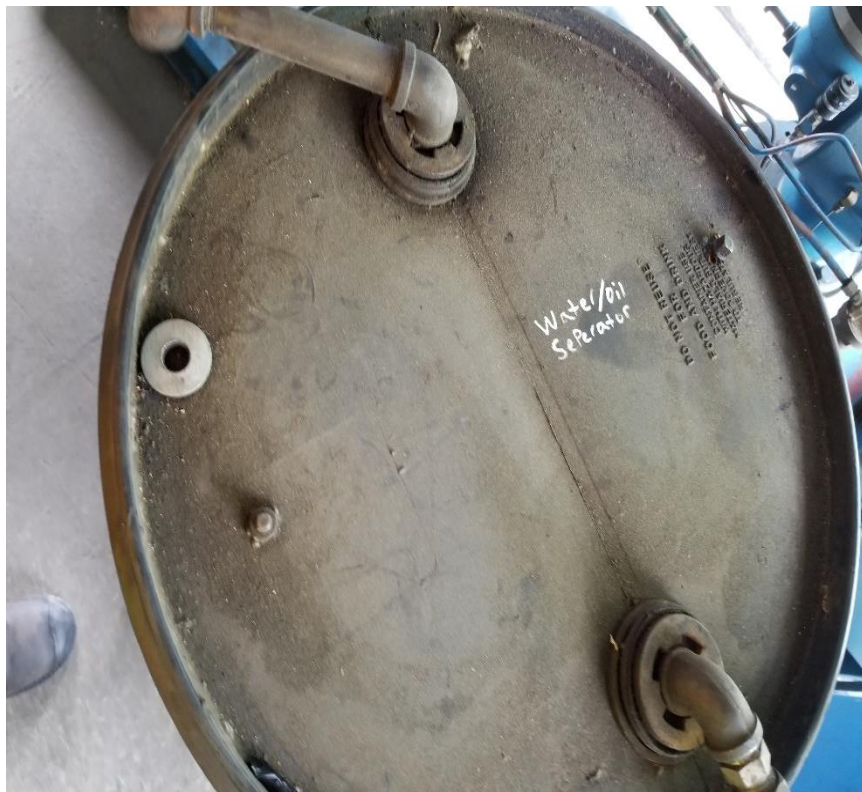
28:

Blue polyethylene container connected to the air-compressor unit located in the in the eastside exterior room.

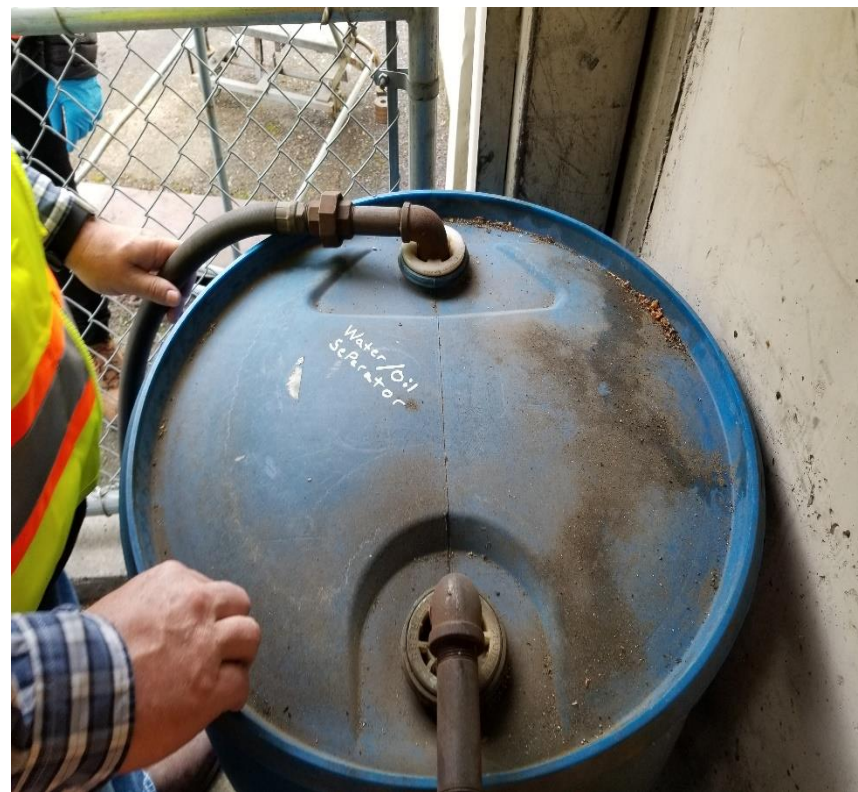
29:

Blue polyethylene container connected to the air-compressor unit located in the in the eastside exterior room.

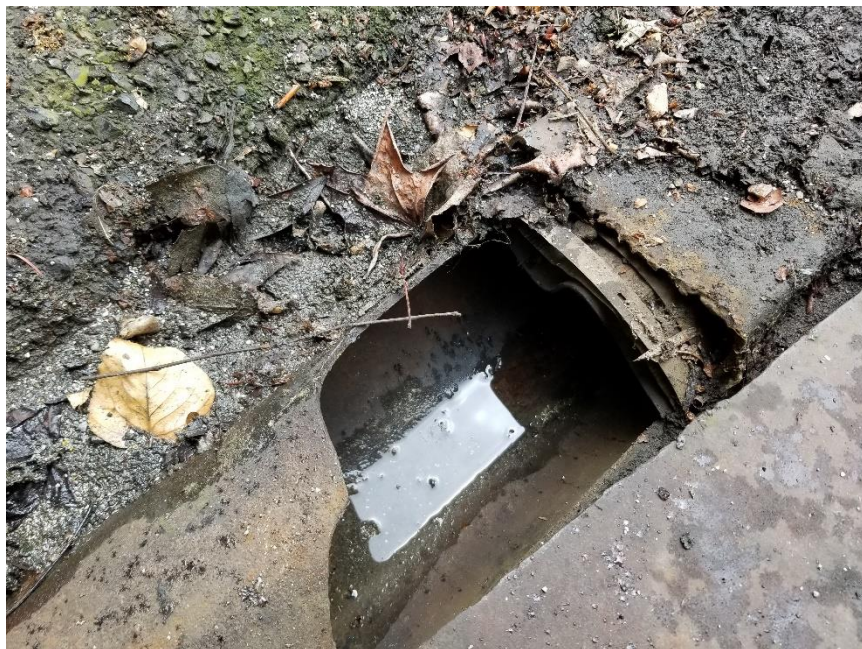
30:

Broken stormwater pipe after black hose and metal plate removed.

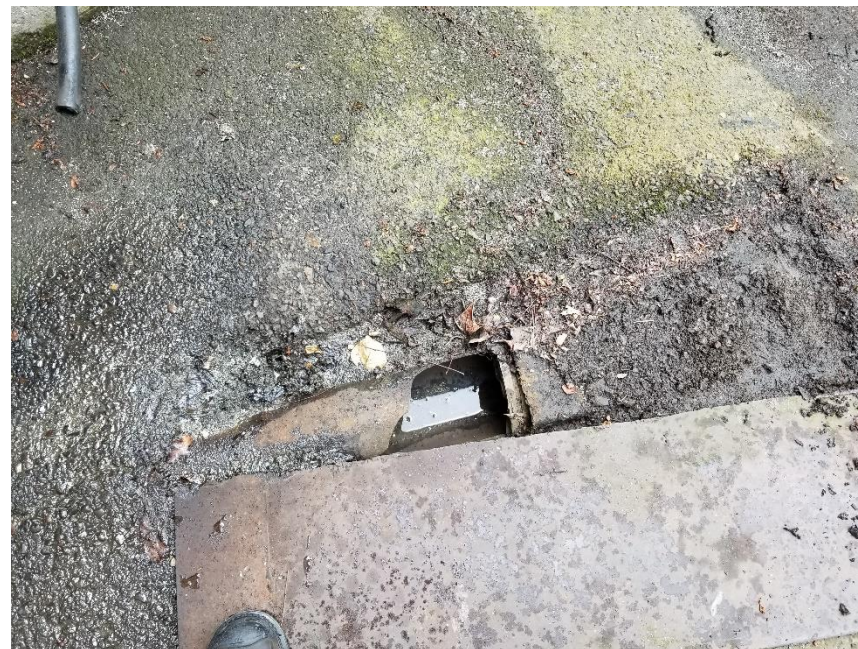
31:

Broken stormwater pipe after black hose and metal plate removed.

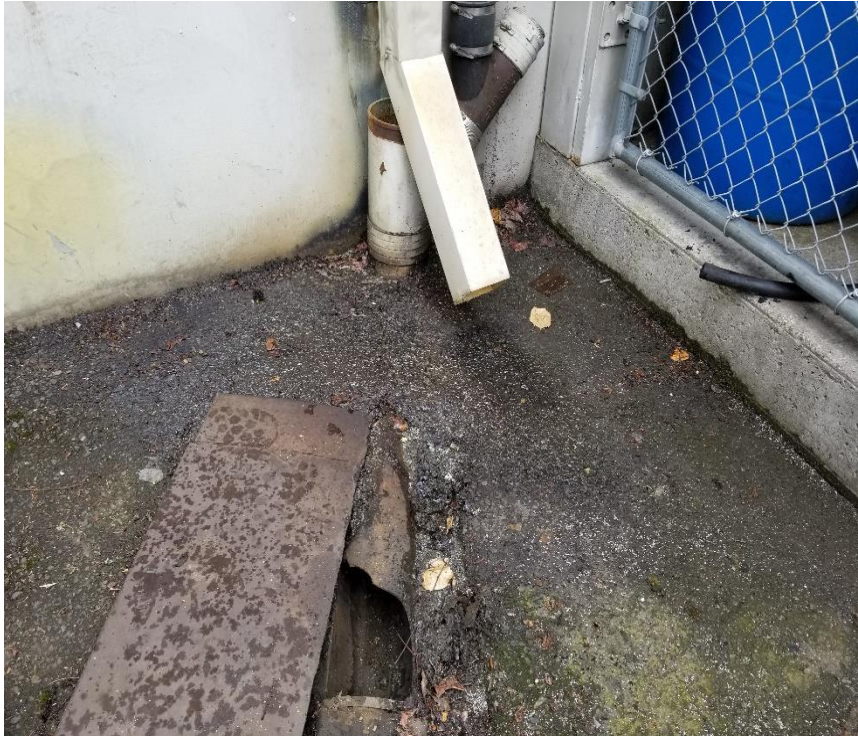
32:

Broken stormwater pipe after black hose and metal plate removed.

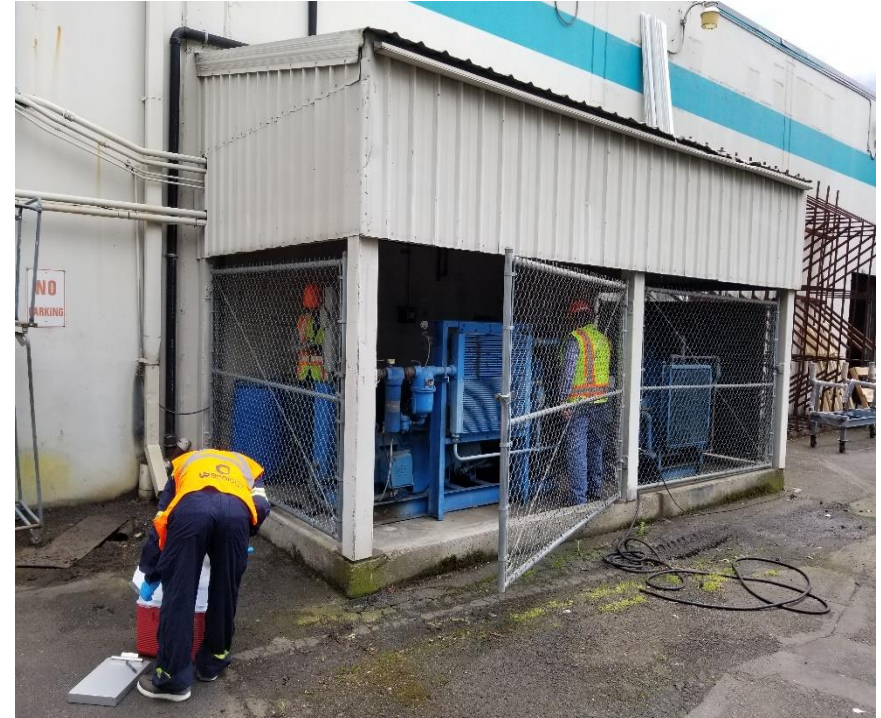
33:

Hydro personnel removing black hoses from stormwater pipe. NRC preparing to collect a swipe sample.

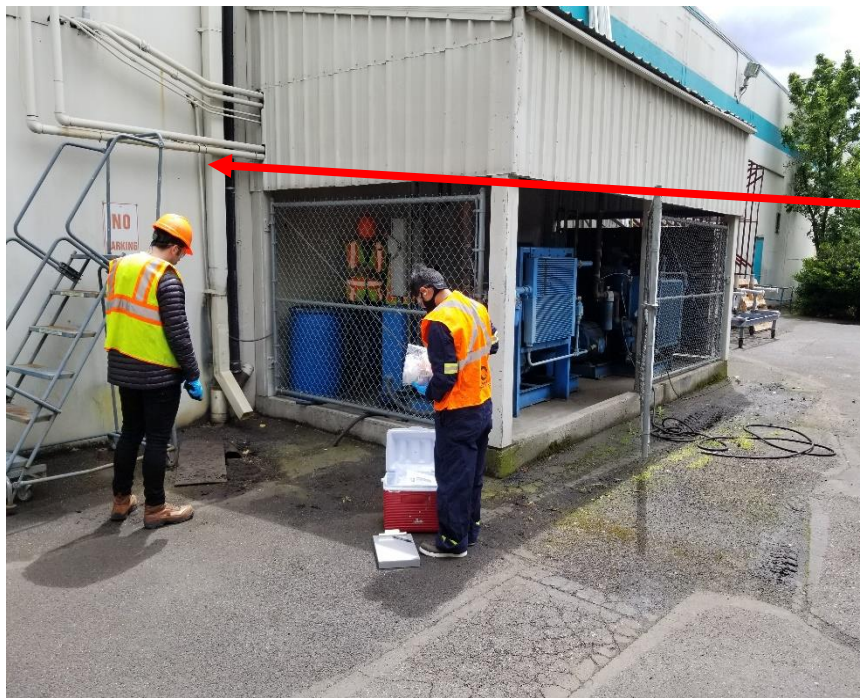
34:

Hydro personnel removed black hoses from stormwater pipe. NRC preparing to collect a swipe sample.

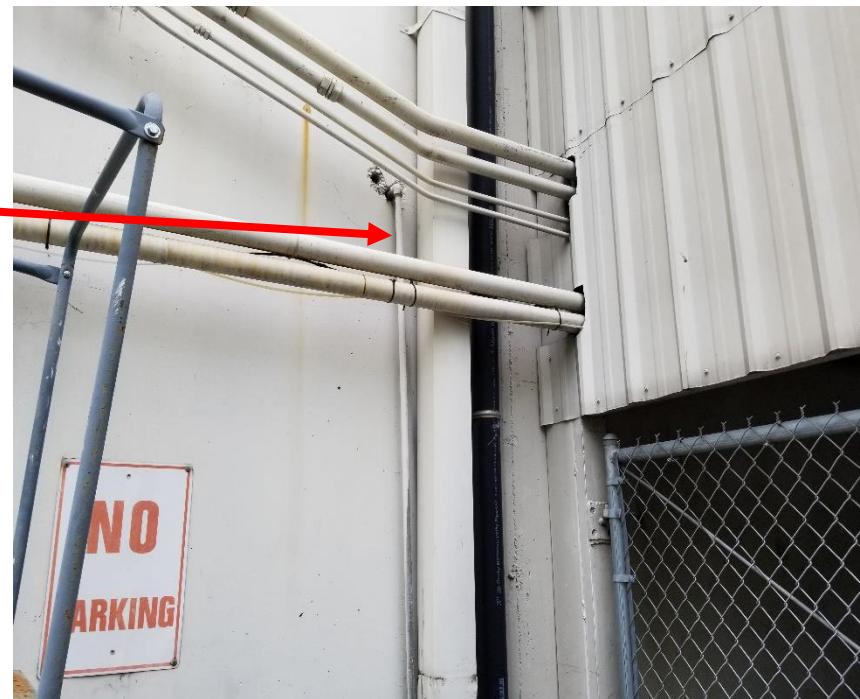
35:

Exterior hard pipe connected to a blue polyethylene container labeled “oil/water separator”.
